In-situ Repair for Improperly cut I-Joists

In-situ Repair for Improperly Cut I-joists

Final Report for Metwood, Inc.

Prepared by Daniel P. Hindman and Joseph R. Loferski

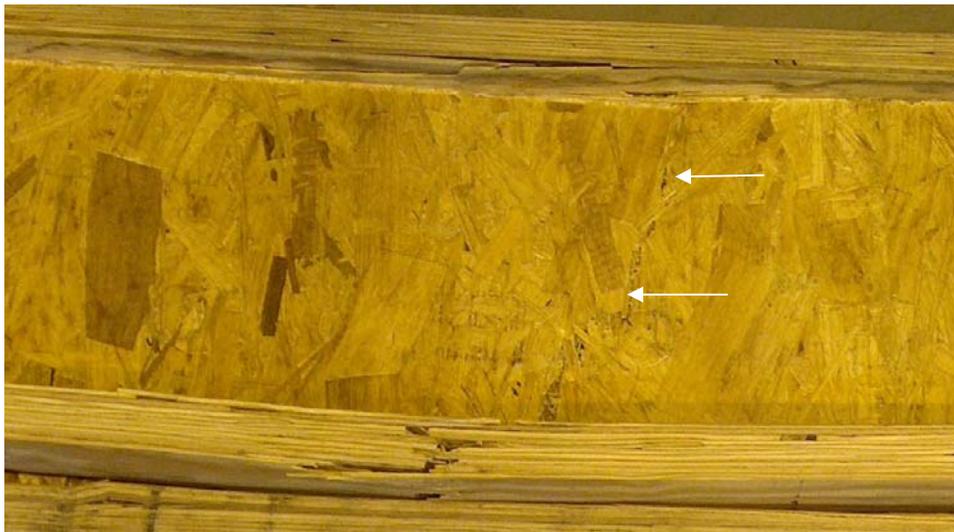
Figure 6: Failure of Control

Figure 6 shows the failure of a Control sample. All of the ‘Control’ beams failed in pure bending towards the center of the span. Figure 6 shows fracture in the bottom flange, delamination of the lower veneers in the top flange and a crack running through the web (white arrows).

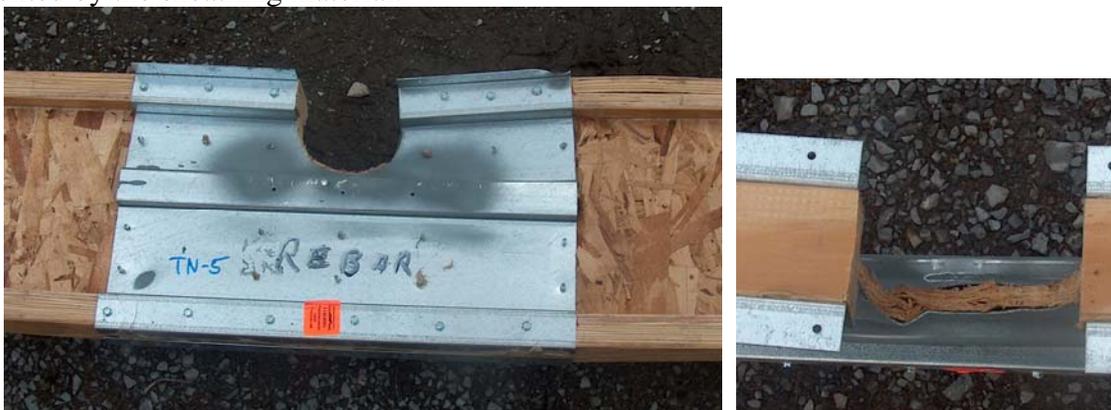
Figure 7: Failure of FlangGW90 Showing Close-Up of Flange Buckling

Figure 7 shows the failure of the FlangGW90 samples. Failure was initiated by buckling of the top flange at the hole in the flange reinforcer. The second image in Figure 7 is a top view showing the permanent deflection of the flanges and the wrinkling of the web and reinforcer below. As stated earlier, this failure mode was considered unrealistic for the situation where the I-joist reinforcers are installed in a sheathed floor, where buckling of the top flange would be prevented by the sheathing material.

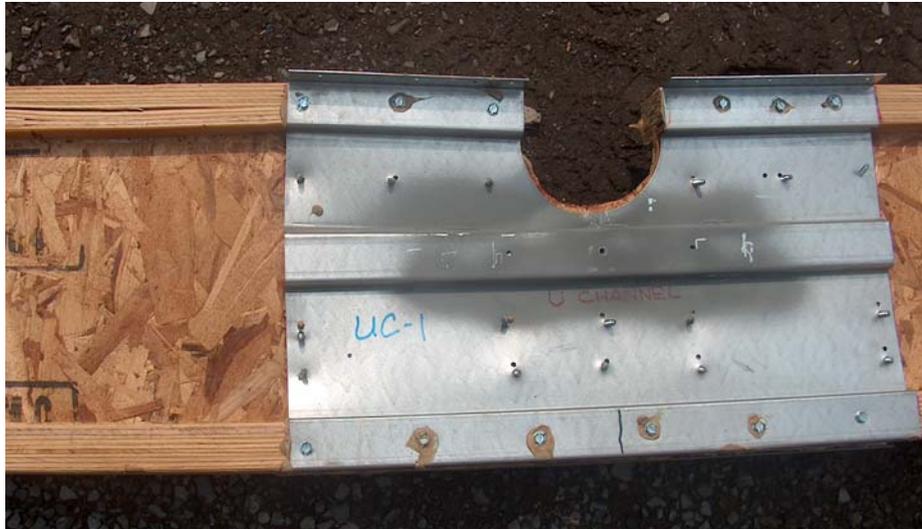
Figure 8: Failure of FlangeG90

Figure 8 shows the failure of the FlangeG90 samples. This failure was consistent with the FlangeGW90 samples discussed in Figure 7. Buckling of the top flange at the point of the cut caused the failure. Note the resulting failure of plies in the top flange to the left of the reinforcer.

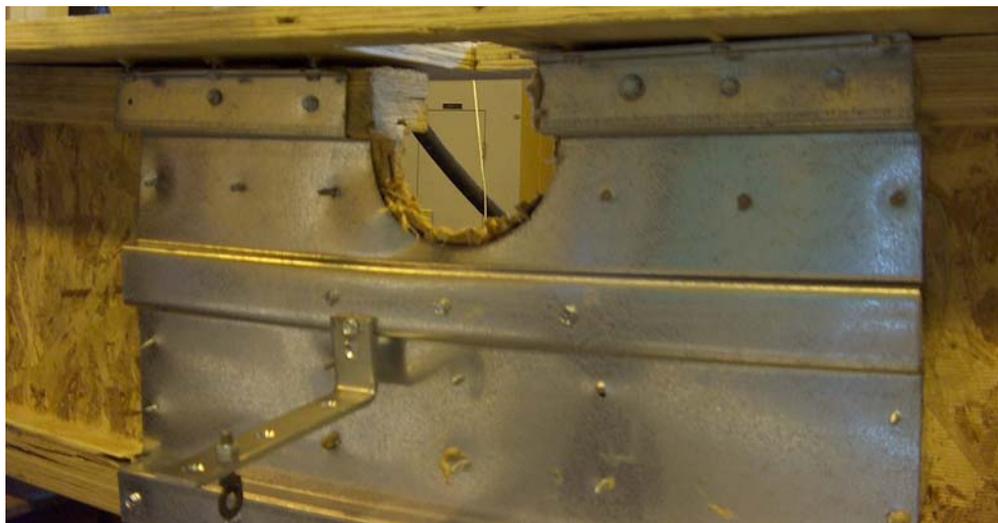
Figure 9: Failure of FlangeGS90

Figure 9 shows the failure of the FlangeGS90 sample. This sample failed by fracture in the bottom flange and the screws attaching the reinforcer to the sheathing pulling out. The bending deformation of the I-joist became so great as to pull out the screws attaching the sheathing to the reinforcer. The fracture of the bottom flange indicates that the failure was caused by bending in the I-joist but not the reinforcer, which is similar to the failures in the Control samples.

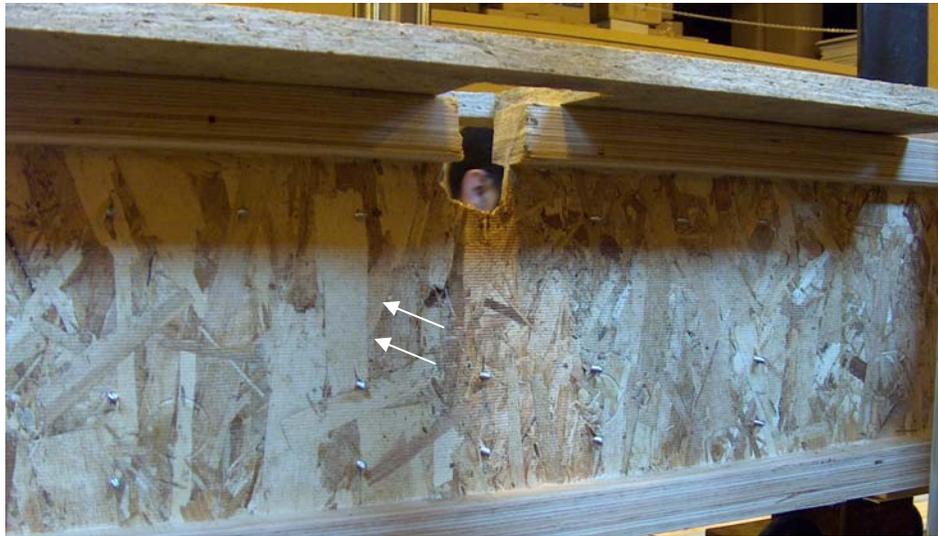
Figure 10: Failure of FlangeSS90

Figure 10 shows the failure of the FlangeSS90 sample. This reinforcer experienced web buckling (white arrows in Figure 10) underneath the hole that was made in the flange. As was noted in the discussion of Tables 3 and 4, using a single flange reinforcer does not produce adequate loads compared to using two flange reinforcers.

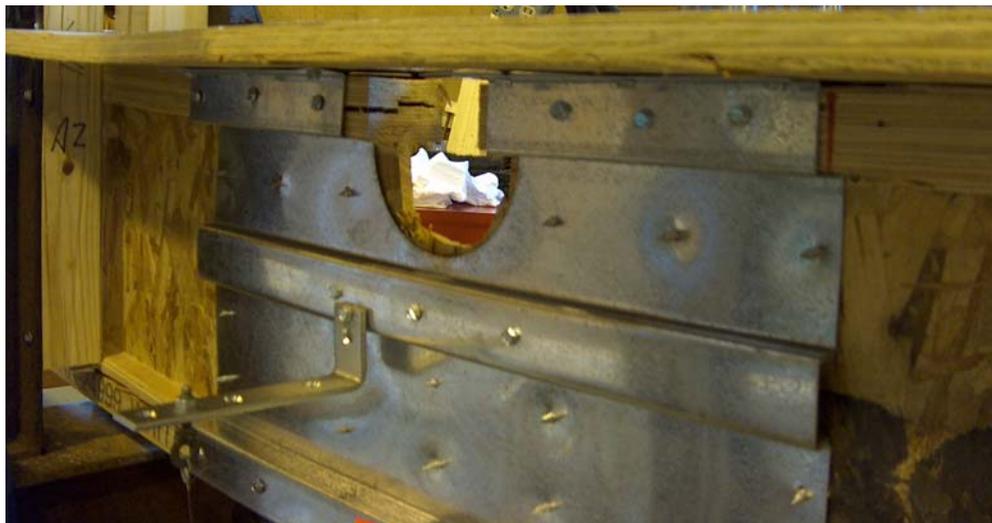
Figure 11: Failure of FlangeS90

Figure 11 shows the failure of the FlangeS90 samples. The reinforcer broke at the bottom flange and also split the top flange along the line of fasteners connecting the reinforcer to the top flange. Also, the excessive deflection of the I-joist caused the screws attaching the reinforcer to the sheathing to pull out.

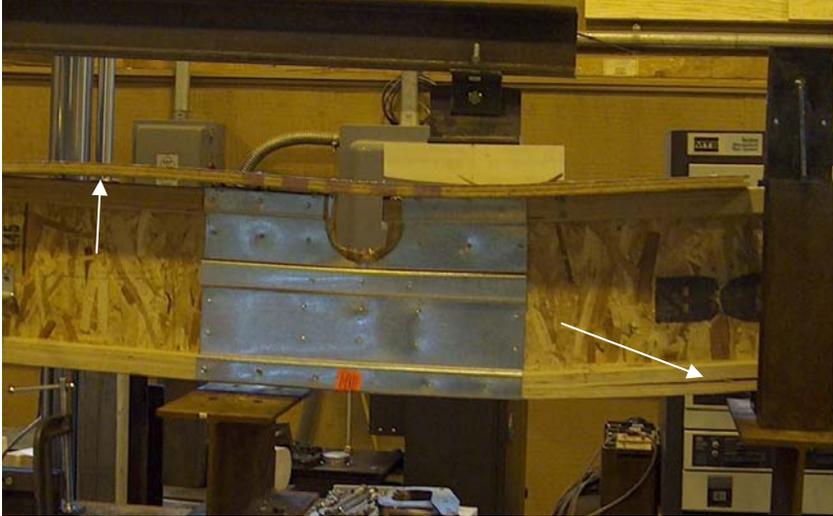
Figure 12: Failure of FlangeS60

Figure 12 shows the failure of the FlangeS60 samples. The failure was a break in the bottom flange caused by horizontal shear in the outer third of the beam. Figure 12 also shows the change in angle of the beam at the outer corner of the reinforcer. In the higher shear area underneath the load head (the reinforcer was initially centered on the load head), the reinforcer acted to strengthen the I-joist, causing a failure in shear at the outer side. Figure 12 also shows the uplift of the top sheathing as the deflection became excessive and the I-joist curvature became large.

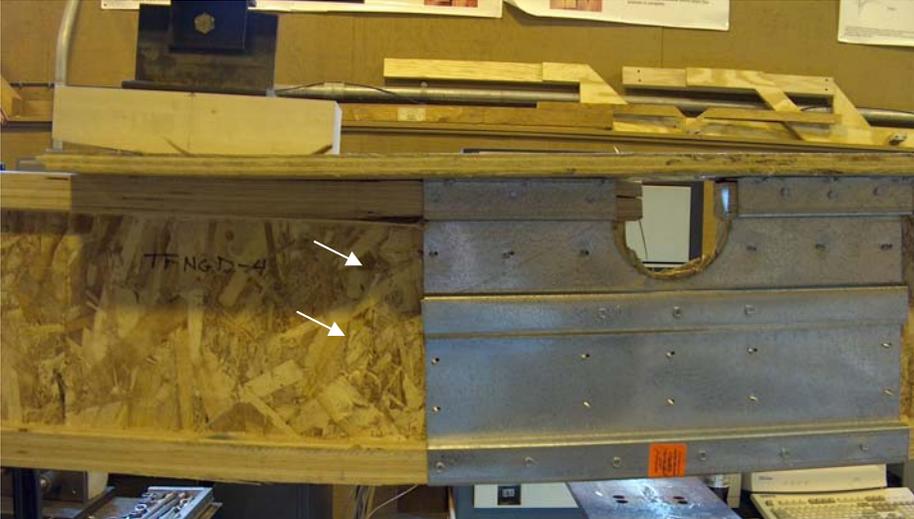
Figure 13: Failure of FlangeS40

Figure 13 shows the failure of the FlangeS40 samples. These samples failed due to web buckling between the reinforcer and the load head. The white arrows point to the buckled material. The buckling initiated with a peeling of the lowest veneer of the top flange. Again, this failure seems to be caused by high shear in the I-joist itself.

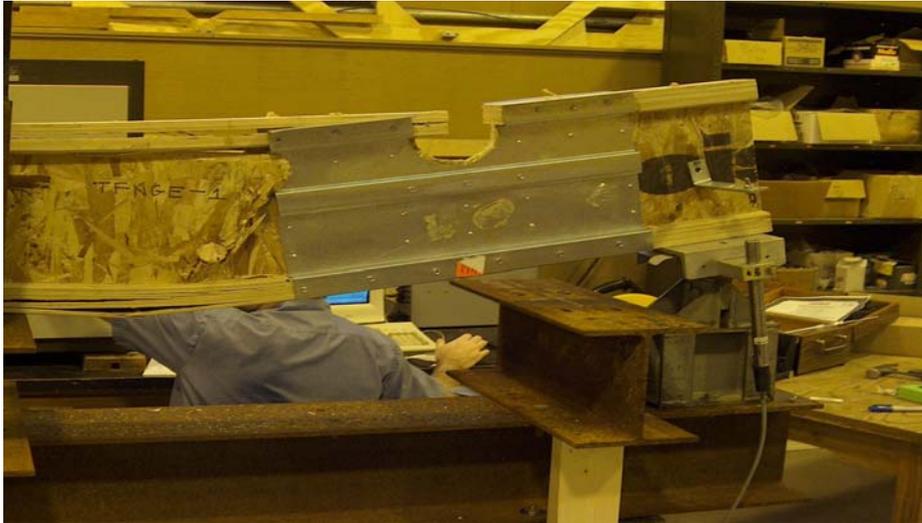
Figure 14: Failure of FlangeS11

Figure 14 shows the failure of the FlangeS11 samples. The failure was due to bending in the flanges and shear in the web of the I-joist itself. The bottom flange is broken at a location away from the reinforcer, the web experienced a shear failure progressing at 45 degrees from the top corner of the reinforcer, while the top flange was broken at the line of screws connecting the flange to the reinforcer.

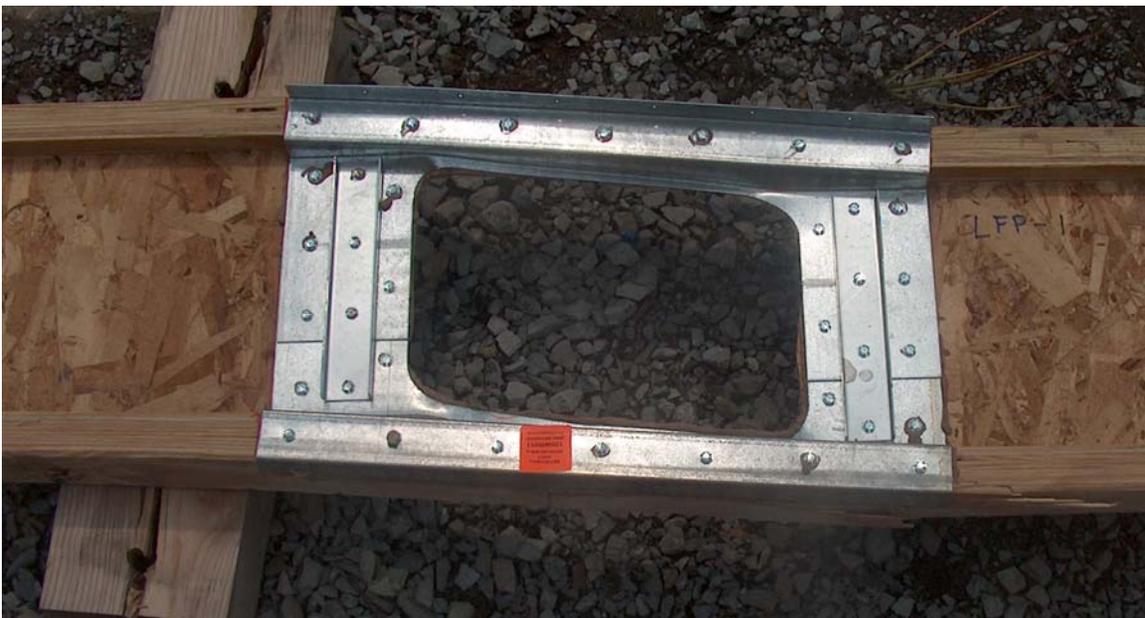
Figure 15: Failure of WebG11

Figure 15 shows the failure of the WebG11 samples. The failure was caused by horizontal shear in the section which caused the reinforcer to become a parallelogram.

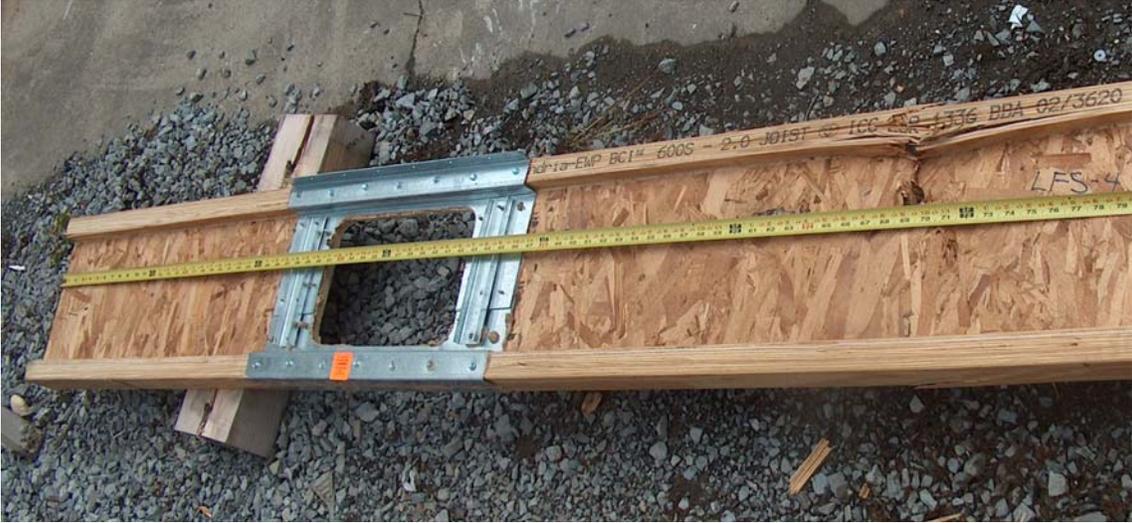
Figure 16: Failure of WebDG11

Figure 16 shows the failure of the WEBDG11 samples. The I-joist failed due to crushing in the web and failure of the top flange. This failure occurred approximately 2 feet away from the reinforcer underneath the load point.

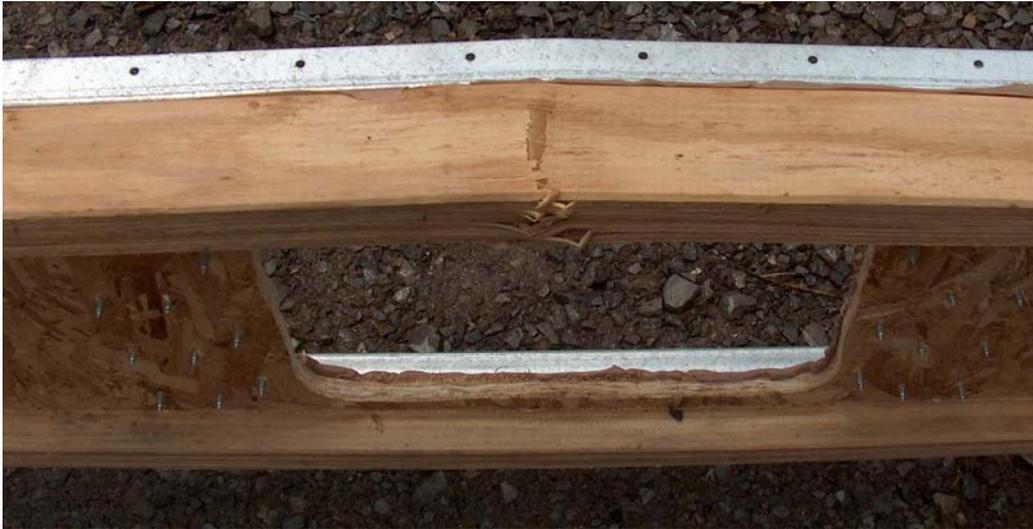
Figure 17: Failure of Web90

Figure 17 shows the failure of the Web90 samples. The failure was caused by buckling of the cross-section, which caused the failure of the top flange, noted by the veneer fibers upraised and broken on the side without the reinforcer. This reinforcer was tested without sheathing and this failure mode was felt to be unrealistic for the situation where the reinforcer is used in an already constructed floor system. The inclusion of sheathing may have prevented this failure from occurring.

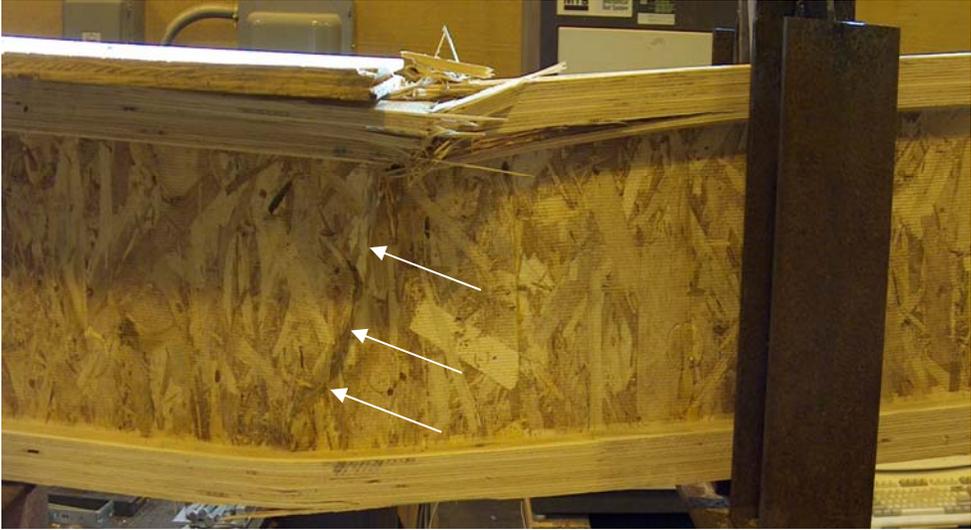
Figure 18: Failure of WebS90

Figure 18 shows the failure of the WebS90 samples. This failure was caused by brash tension in the top flange due to bending stresses with buckling in the web (series of white arrows). This failure occurred approximately 24 inches from the center of the reinforcer at the edge of the sheathing section. In Figure 18, the web reinforcer itself is not visible.

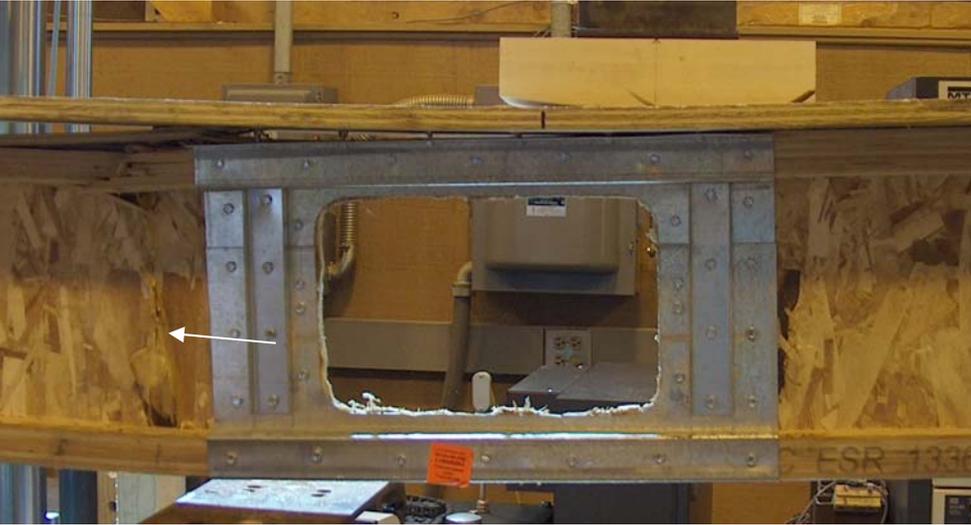
Figure 19: Failure of WebS60

Figure 19 shows the failure of the WebS60 samples. These reinforcers were positioned directly underneath the support points. Failure occurred through brash tension in the flange due to bending stresses approximately 6 inches from the edge of the reinforcer. Also, note the failure of the web section underneath the flange failure (white arrow).

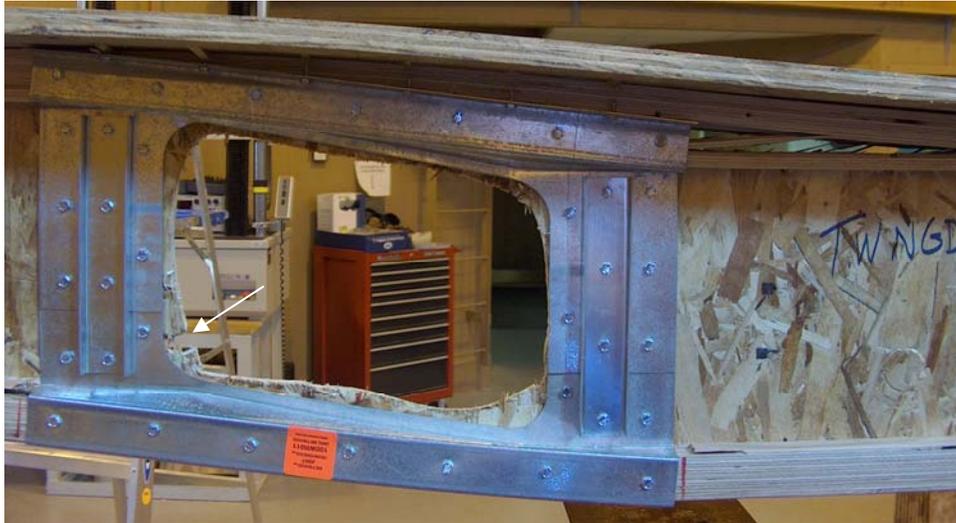
Figure 20: Failure of WebS40

Figure 20 shows the failure of the WebS40 samples. The samples failed in horizontal shear, which caused failure of the web-flange joint in the top flange (note the peeling of the top flange veneers in the upper right corner) and failure of the web (white arrow in lower left hand corner). The outer third of the beam tested is where the highest shear force, which led to failure, was present.

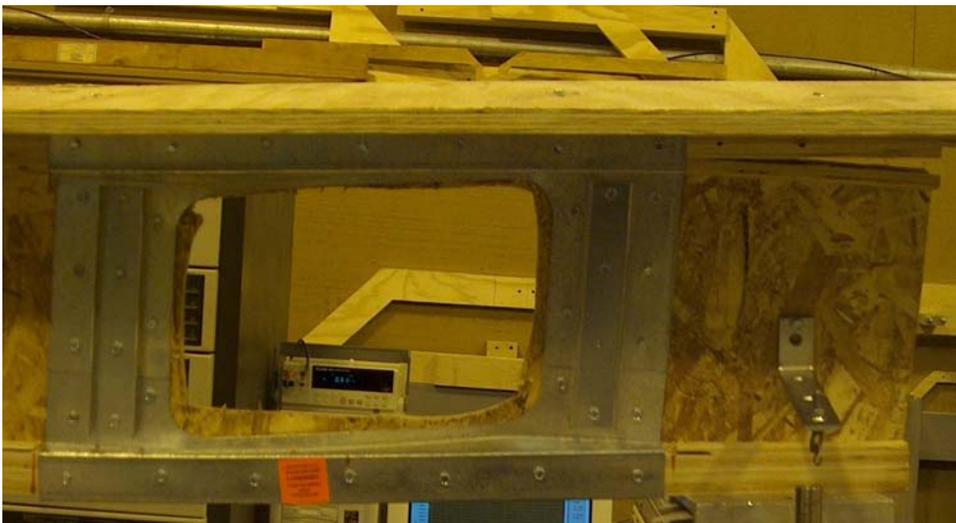
Figure 21: Failure of WebS11

Figure 21 shows the failure of the WebS11 samples. The web reinforcer failed in horizontal shear which caused breakage web-flange interface in the top flange along with distortion of the web reinforcer into a parallelogram shape. In this position, which was in the high shear zone, the failure was due to shear stress.
